SHEAR BOND STRENGTH OF PREVENEERED POSTERIOR STAINLESS STEEL CROWNS

Purpose: The purpose of this study was to evaluate the shear bond strength of veneer material of posterior preveneered stainless steel crowns (SSCs).

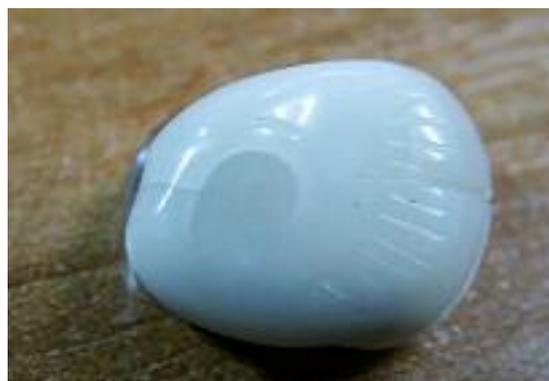
Figure 1. Cohesive failure, cracking in the veneer material of upper second primary molar (Original magnification X10)

fracture extents were compared using Kruskal-Wallis test, there were no significant differences between crown groups ($P>0.05$). The fractures that occurred at veneer material of each crown group were characterized either cohesive or mixed failures (Figs. 1 and 2). Specimens showed cracking, loss of a third or one second fracture extends (Figs. 1, 2, 3 and 4). None of the specimens had loss of complete at fracture extent. In addition, dislodged veneer material was observed by a spalling (Fig. 3).

In this study, failure types of veneer material were cohesive or mixed failure (adhesive/cohesive) (Table 2; Figs. 1 and 2). None of them showed adhesive

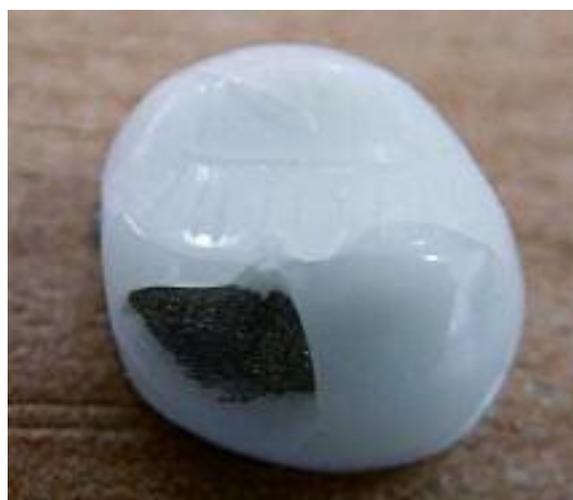
Figure 2. Mixed failure, spalling, loss of a third of the veneer material of upper second primary molar (Original magnification X10)

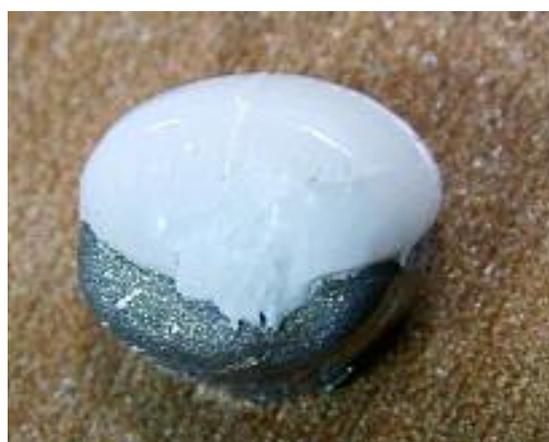
Figure 3. Mixed failure, loss of one second of the veneer material of lower first molar (Original magnification X10)

failure. The probable cause of why adhesive failure was not observed can be due to the fact that the veneer material was bonded to stainless steel base using the sandblasting method. In addition, separation from stainless steel base of veneer material was characterized by a spalling (Fig. 3). These results were agreed with failure modes observed in the previous studies which were used preformed NuSmile crowns^{9,10,20,21}. Perhaps the observed failure types might be due to the fact that veneer material was bonded to stainless steel base using the sandblasting method. Moreover, the extents of fracture of veneer material in the study were cracking, loss of a third or loss of one second of the veneer. These findings are in agreement with that of previous study, in which NuSmile primary anterior crowns were tested²¹.

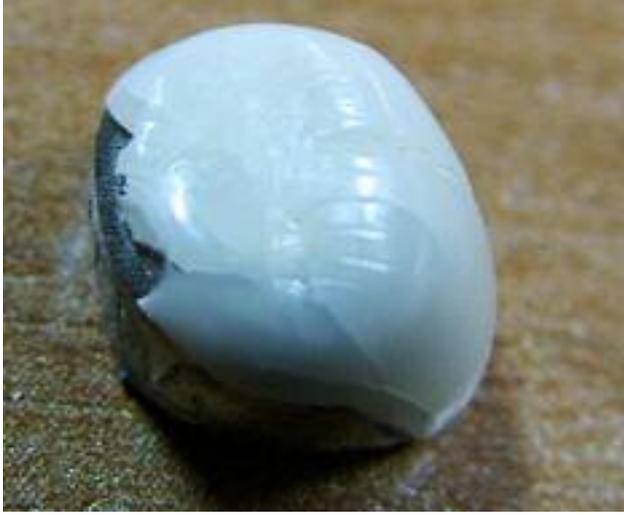
Figure 4. Mixed failure, loss of a third of the veneer material of lower first molar (Original magnification X10)
