THE ASSESSMENT OF OSSEOINTEGRATED DENTAL IMPLANT FRACTURE: A CASE REPORT

Fracture of dental implants is a rare situation with severe clinical results. The aim of the present report was to describe the management of a fractured endosseous dental implant replacing the maxillary left canine.

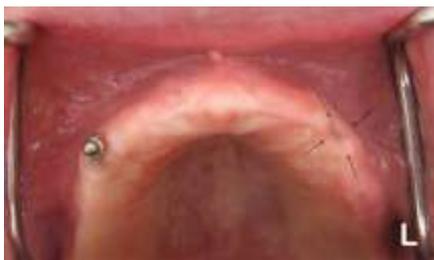
A 55-year-old woman was referred to the clinics of Oral and Maxillofacial Surgery Department with a chief complaint of fractured dental implant. Intraoral examination revealed that the fractured dental implant which was supported overdentures with ball-attachment systems, and was replacing the maxillary left canine (Figure 1). The clinical examination revealed an overdenture type prosthesis supported by two thread osseointegrated implants (Figure 2). The patient's implant placement and prosthesis had been done at another clinic. The implant was broken sixteen months after the prosthesis was placed (Figure 3,4). It was seen that the fractured implant was ITI (Straumann AG, Switzerland) cylindrical dental implant, 12 mm in length and 3.3 mm in diameter. Radiographic examination showed no signs of periimplantitis and lack of osseointegration in any of the inserted implants. The patient has class III occlusion and had any systemic problems except for hypertension. The patient's alveolar crest bone destruction was not present and alveolar crest was appropriate for insert a dental implant. The abnormal masticator forces were absent at patient. Because osseointegration of the fractured implant was perfect and its removal could have caused a quite much bone volume loss, we preferred not to remove the fractured implant and to insert a new dental implant next to the existing fractured one. In addition, we suggested to patient which insert an implant in the midline in both jaws. However, the patient did not accept extra implants because of economic reasons. A 12 mm in length and 4.1 mm diameter cylindrical Straumann dental implant was inserted in approximately 4 mm away from the fractured implant's distal area in our department (Figure 5). After six-months of healing period with no complications noted, clinical osseointegration was achieved (Figure 6,7), and then a new prosthesis was made and the patient was followed for the next two years. Fractured implant piece was not symptomatic. The patient had any complaint and was very pleased.

Figure 1. The intra-oral image of the patient

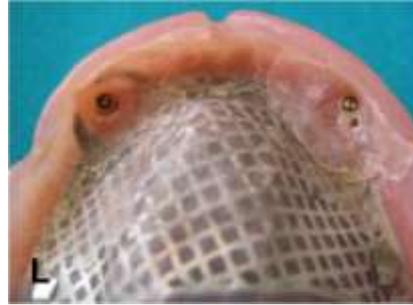
Figure 2. The overdenture type prosthesis supported by two dental implants

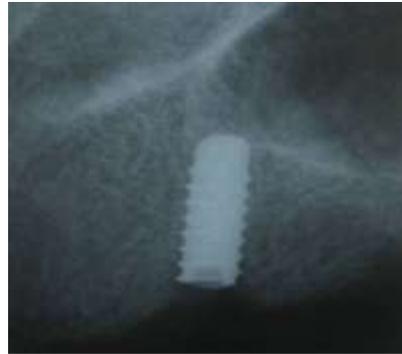
Figure 3. Radiography showing that the fractured dental implant was osseointegrated

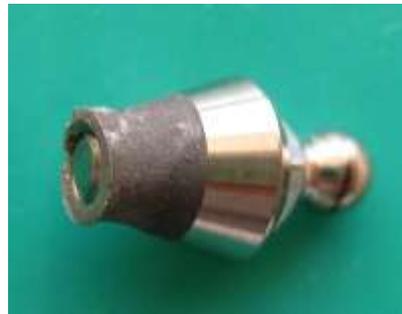
Figure 4. The fractured dental implant

implant fractures.^{1,7,9} In this case, we estimate that the cause of the fracture is metal fatigue occurred due to the prosthetic failure. Other causes can be the implant's small diameter, and the patients' class III occlusion.

In conclusion, it should insert four implants and wider implants instead of two to minimalise fracture risk on apply dental implants.

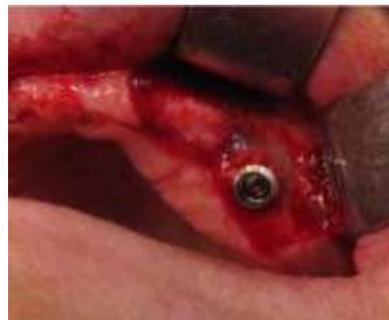
Figure 5. Dental implant was inserted in to the fractured implant's distal area

Gargallo et al⁷ reported that it was important to know and apply the measures required to prevent implant fracture and to seek the best individualized solution for each case, though complete implant removal is usually the treatment of choice. In the present case, a wider dental implant from the same brand was inserted in the fractured implant's distal side without removing the fractured implant.

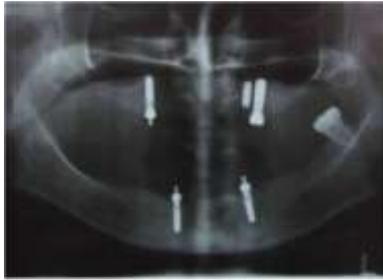
Figure 6. Final panoramic radiograph

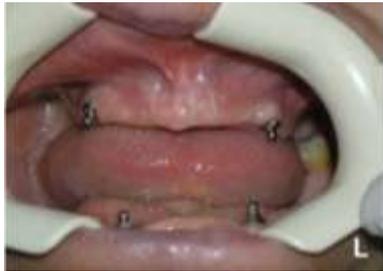
Figure 7. Final appearance of the implants
