## EFFECT OF SEPARATED ROTARY INSTRUMENTS ON THE APICAL MICROLEAKAGE OF ROOT CANAL FILLINGS#

**Aim:** The aim of this in vitro study was to compare the effect of separated fragments from two different nickel titanium rotary instruments on microleakage of the root canal filling.

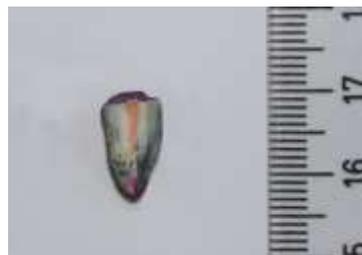
Figure 3. An example of sectioned root.

The teeth were then sectioned longitudinally from the buccal-lingual direction using a diamond disc without damaging the root canal filling (Figure 3). Digital photographs were taken of all the sections of roots. Marginal leakage of fuchsin dye (Figure 4) was evaluated with AutoCAD and Photoshop image analysis software.

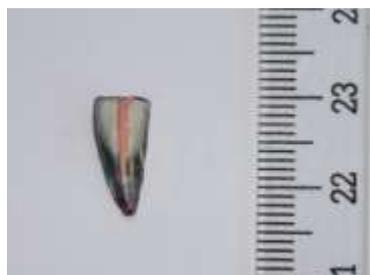
Figure 4. An example of dye leaked separated file.
