THE MODIFIED LAMINATE VENEER RESTORATIONS WITH COMBINED PROSTHODONTIC RESTORATIONS ON TRAUMATIC TEETH (CASE REPORT)

Makale Kodu/Article code: 1819
Makale Gönderilme tarihi: 11.08.2014
Kabul Tarihi: 14.12.2014

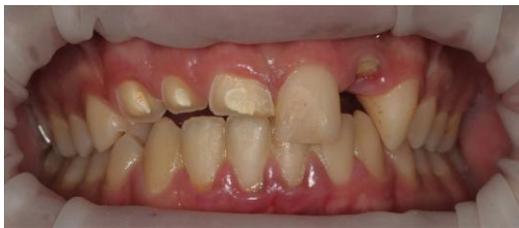
A 14-year-old boy was referred to our clinic with a recent history of a sport-related injury to the maxillary right central and lateral incisors and canines (Fig. 1). After clinical and radiographic examination, endodontic treatment was planned for the fractured teeth. For the missing left lateral incisor, a 3-unit all-ceramic fixed dental prosthesis was considered. Any implant supported prosthesis was not selected because of the economical restriction. A week after endodontic treatment of the fractured teeth, a fiber-reinforced composite post (FRC Postec Plus, Ivoclar Vivadent, Liechtenstein) and composite core (Multicore Flow, Ivoclar Vivadent, Liechtenstein) were fabricated to restore the right canine prior to complete crown preparation. The reason why a complete crown restoration was selected for the right canine was that the patient had the canine guided occlusion. So, a complete crown restoration was selected because of the canine's position in the occlusal plane. Chamfer finishing lines were generated, as was done for the gingival margin of the relevant canine and the other teeth involved (Fig. 2).

Figure 1. The first appointment of the patient before treatment

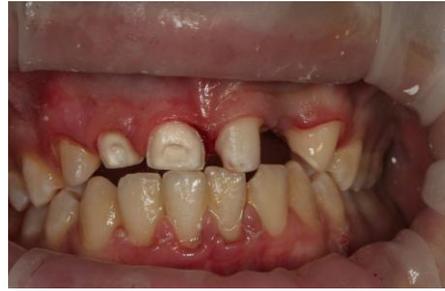
Figure 2. Coronal post and laminate preparations

The gutta-percha and endodontic cement of the right central and lateral incisors were removed using a round bur to a depth of 3 mm into the root canal. Glass ionomer cement was placed into the canal orifice to prevent discoloration. To achieve an esthetically favorable border with the gingiva, bipolar electrocauterization was adopted. Retraction cords (Ultrapak 0; Ultradent Products Inc., South Jordan, UT, USA) were used to expose the preparation area around the gingival margin. Laminate veneer preparations were then performed via a conservative approach terminating approximately after 1-mm incisal and labial reduction. Two wooden supports derived from sterile pieces of toothpicks were cut and fitted into the coronal post canal to obtain the required impression. A definitive impression of the prepared teeth was made using polyvinylsiloxane impression material (Virtual Putty and Lightbody, Ivoclar Vivadent Liechtenstein). The interim prostheses were fabricated and inserted into the relevant teeth. The Lava ceramic porcelain system (3M ESPE, St. Paul, MN, USA) was used in the fabrication of the final restorations (Fig. 3). Initially CAD/CAM supported frameworks which include post and core were designed for the treated teeth with CEREC inLab system. In this system, cast model was fabricated from the impression taken from the patient. Then, model was scanned by CEREC camera in the laboratory (CEREC Bluecam, Sirona). Also, the frameworks for the complete crown and 3-unit all-ceramic fixed dental prosthesis were produced by the same method. Prior to veneering, preparation of the frameworks was completed by using CEREC system (CEREC Bluecam, Sirona) with Lava blocks and Lava frameworks were tried on the patient. Then, veneering ceramic was fired on to best fitting frameworks in the right color. Finally, canine guided occlusion was adjusted accordingly.

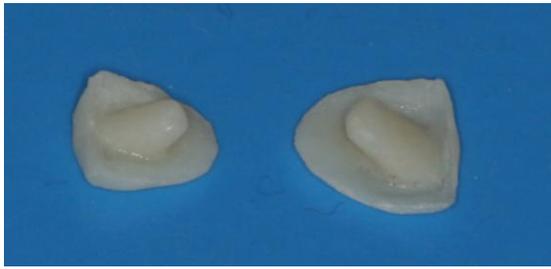
Figure 3. Modified laminate veneer restorations

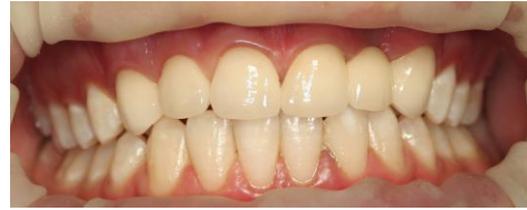
Figure 4: Post-operative treatment of the patient

After final training and finishing, restorations were glazed and cemented using a dual-curing composite system. Initially, all tooth surfaces were etched using 37% phosphoric acid (Total Etch; Ivoclar-Vivadent, Liechtenstein) for 15 s, rinsed for 10 s, and then gently dried for 5 s. Internal surfaces of the Lava restorations were treated with 30- μ m silica-modified alumina particles which were silica coated (Cojet Sand, 3M ESPE, St. Paul, MN, USA) at 0.2 Mpa pressure, then rinsed for 60 s and air dried for 20 s. A layer of silane (Monobond S, Ivoclar-Vivadent, Liechtenstein) was applied to the inner surfaces of restorations for 60 s, then air dried. The primer (Syntac Primer; Ivoclar-Vivadent, Liechtenstein) and the adhesive (Syntac Adhesive; Ivoclar-Vivadent, Liechtenstein) were applied to the tooth surfaces consecutively according to the manufacturer's instructions. An unfilled resin-bonding agent (Heliobond; Ivoclar-Vivadent, Liechtenstein) was applied with a brush and thinned by air drying for 3 s. Dual-polymerizing composite resin cement (Vaiolink II, Ivoclar-Vivadent, Liechtenstein) of the appropriate shade was applied to the restoration. The restoration was positioned appropriately to the restoration area and excess cement was removed. The luting agent was polymerized with an LED device (Bluephase, Ivoclar-Vivadent, Liechtenstein) at 470 mW/cm² power for 40 s. The patient was informed of the importance of oral hygiene and regular follow-up (Fig. 4). He was satisfied with the results after 2 years and did not complain of any functional or coloration-related problems.
