TREATING A TRAUMATISED MAXILLARY CENTRAL INSIZOR WITH MONOBLOCK POST-CORE-CROWN RESTORATION: A CASE REPORT

Fabricating a restoration which can serve clinically long term without any sign of complication and fulfill the functional and esthetic requirement is very hard to achieve in excessively damaged tooth especially when it is in the esthetic zone. The following case report presents an alternate method for the treatment of excessively damaged tooth which can diminish the ability of complication in the traditional treatment modality and as well as can fulfill the esthetic and functional demands of the patient.

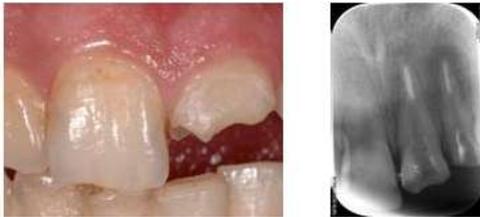
Root canal treatment was performed under rubber dam isolation. Cleaning and shaping of the canal was made to size 60 K-file accompanied by copious irrigation with 1% sodium hypochlorite and obturation was done with gutta-percha and AH-Plus sealer (Dentsply DeTrey, Konstanz, Germany) by lateral condensation technique. Gutta-percha was removed with a heated endodontic condenser and post space prepared using Peeso Reamers sizes 1 to 4 while ensuring 4 mm of remaining apical gutta-percha for adequate apical seal(Fig. 1).

Figure 1. Fractured tooth and prepared post space.

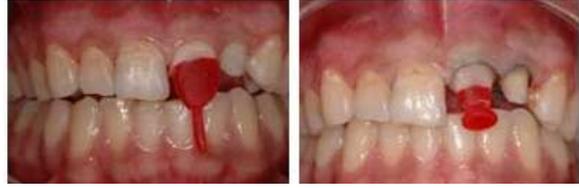
The impression of the post space was taken with self curing acrylic resin (Pattern resin, Gc America inc. ALSIP, IL 60803 USA). Prior to impression the post space was isolated with petroleum jelly for easy removal of the polymerised acrylic resin from the root canal. Preparation of the remaining tooth and acrylic resin-core was made with diamond burs with a chamfer finish line(Fig.2).

Figure 2. Creating a retentive button to the core ensured the immobilisation of the resin post- core in the final silicone impression.

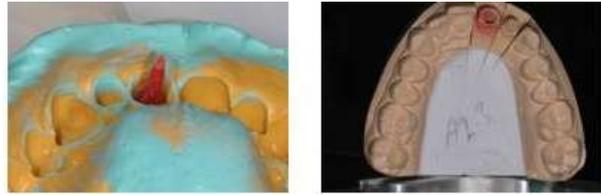
Following gingival retraction, impression was taken with additional type silicone material(Panasil, Kettenbach GmbH&Co.KG Eschenburg, Germany). Impression was poured with type IV dental stone(Fig.3).

Figure 3. Acrylic resin post-core in silicone impression and master stone cast.

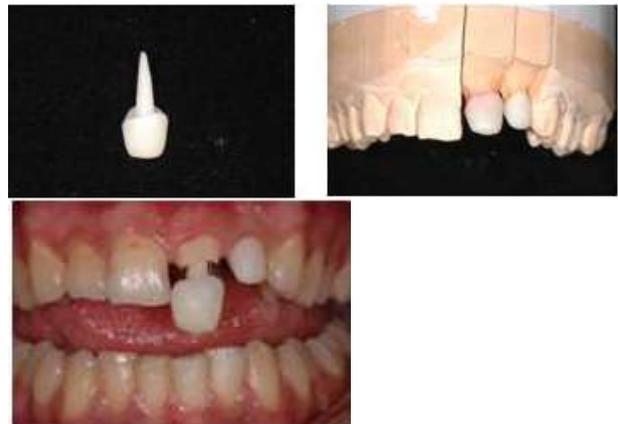
Stone cast model was prepared and mounted to a semi adjustable articulator (Denar Advantage, Whip mix Corporation, USA). When acrylic resin post was in stone model, wax pattern of the crown substructure was built up on it and the assembly was cast with Li-disilicate ceramic(Fig.4)

Figure 4. Li-disilicate post-core.

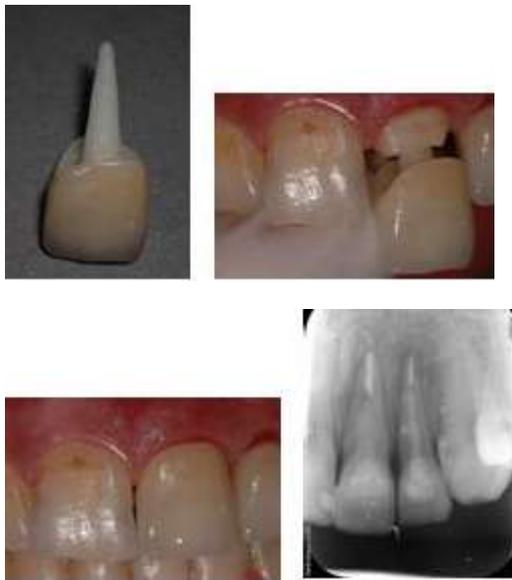
After checking marginal fit, the substructure was veneered with veneering ceramic to give a lifelike appearance. The finished restoration was evaluated for fit, shade, and occlusion prior to cementation, gingival retraction cord was placed, and then the restoration was luted with a dual cure composite luting agent (Panavia F, Kuraray medical Inc, Okayama, Japan). The excess luting agent was removed with a scalpel and all accessible margins were finished using fine diamonds and polished with rubber points and diamond polishing paste. The cemented restoration was evaluated clinically and radiographically for marginal fit (Fig. 5)

Figure 5. Finished post -core – crown restoration.
